# Manhole Inspection Summary

Manhole # S49EE\_005MH

Insp Date: **7/13/08 10:42 AM**

**Location** Address: **milton st**

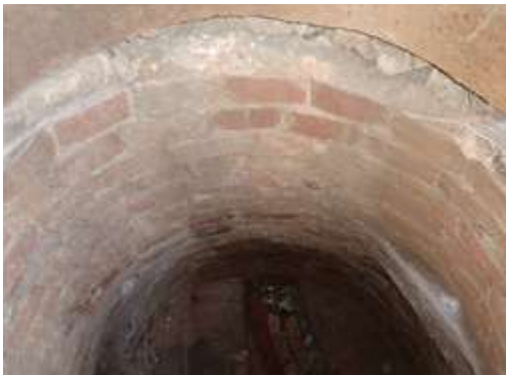
Defect 2

☒ **Leaks**

frame leaks

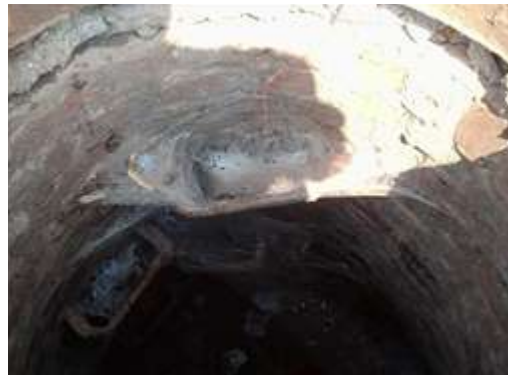
Defect 1

Infiltration: ☐ None ☒ **Joint** ☐ Cracks ☐ Mortar ☐ Roots ☐ Wall

Infiltration: ☐ None ☐ Joint ☐ Cracks ☐ Mortar ☐ Roots ☒ **Wall**

infiltration

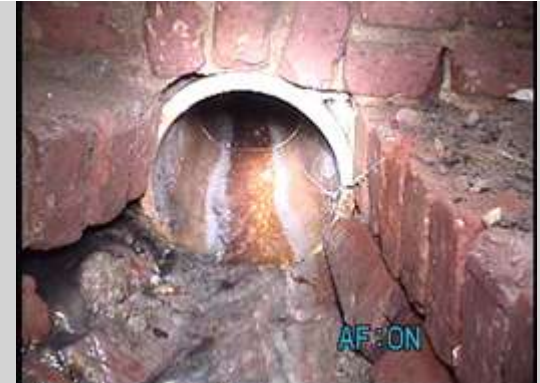
12 O'Clock Outflow

Pipe Height: **8.4** (in.) Rod and Bar (Angled)  
Pipe Material: **Clay** ☐ Pipe Lined  
Invert Depth: **8.70** (ft.) Flow Characteristics: **Slow**  
Deposits: ☒ None ☐ Mud ☐ Sludge ☐ Debris ☐ Grease  
Silt Depth: (in.) Deposits Extent:  
Infiltration: **None** Pipe Seal Cond: **Sound**

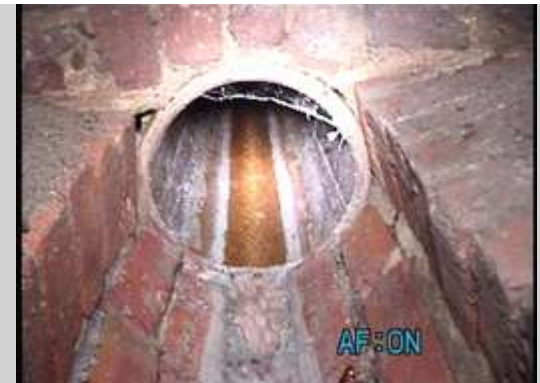
6 O'Clock Inflow

Pipe Height: **8.4** (in.) Rod and Bar (Angled)  
Pipe Material: **Clay** ☐ Pipe Lined  
Invert Depth: **8.60** (ft.) Flow Characteristics: **Slow**  
Deposits: ☒ None ☐ Mud ☐ Sludge ☐ Debris ☐ Grease  
Silt Depth: (in.) Deposits Extent:  
Infiltration: **None** Pipe Seal Cond: **Sound**

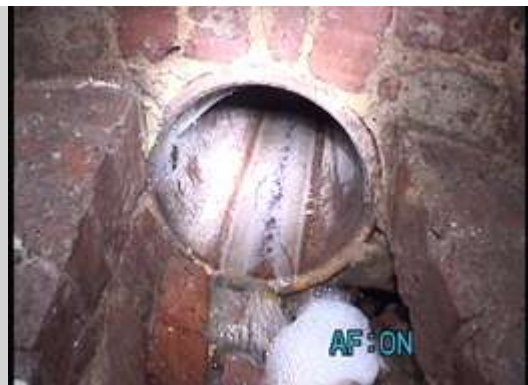
9 O'Clock Inflow

Pipe Height: **8.4** (in.) Rod and Bar (Angled)

Infiltration: **None** Pipe Seal Cond: **Sound**
